检测报告 编号: TSNHG2400173301 日期: 2024年01月24日 第1页,共3页

样品名称: 橡塑地板

SGS工作编号: TJHL2401000572SD - TJ

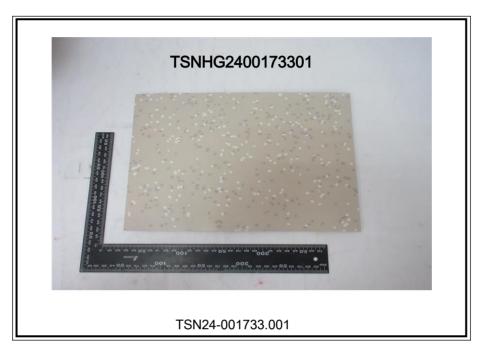
样品照片:

SN1 TSN24-001733.001 带彩色印刷的灰色片(混测)
